ANNUAL REPORT FOR 2005

Wiggins Mill Mitigation Site
Wilson County
Project No. 8.1330509
TIP No. R-1030WM

Natural Environment Unit & Roadside Environmental Unit
North Carolina Department of Transportation
December 2005

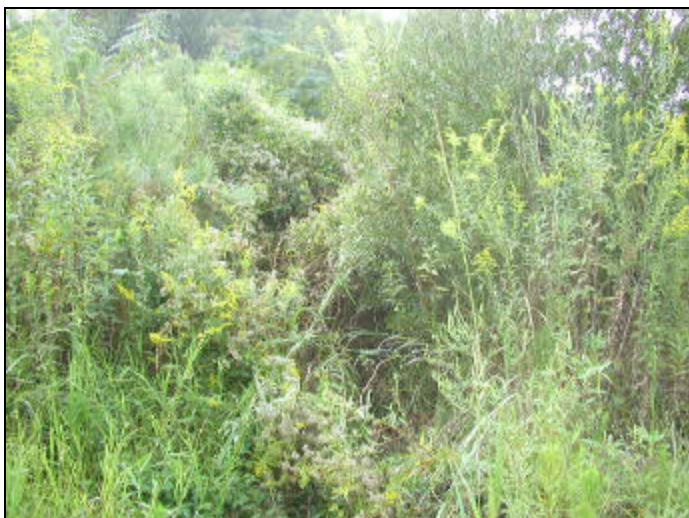
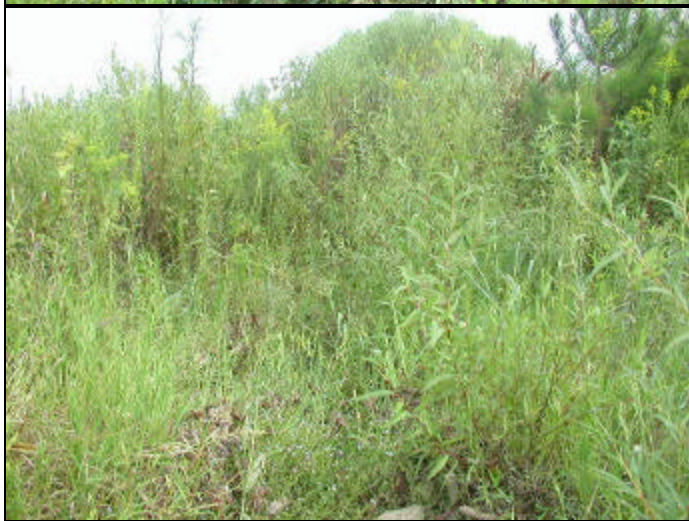
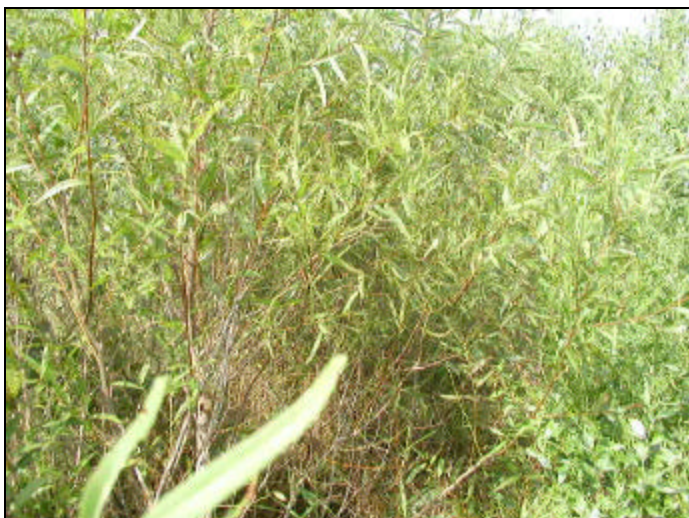
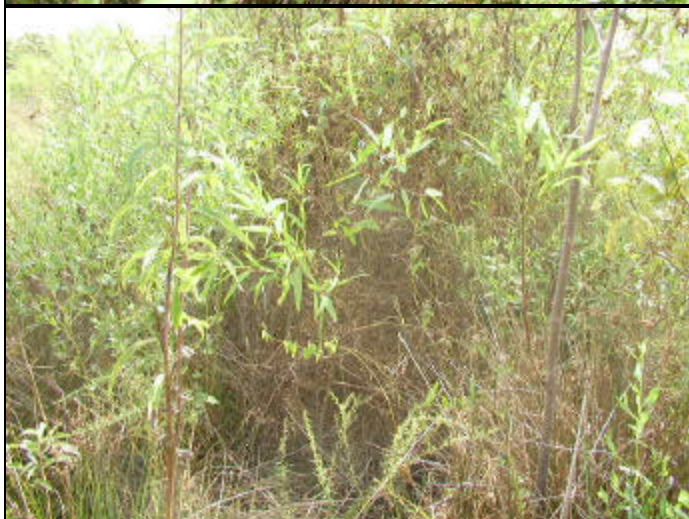
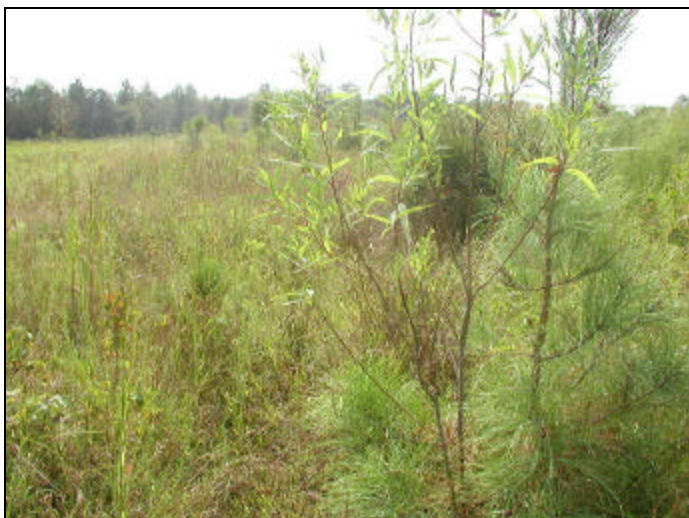
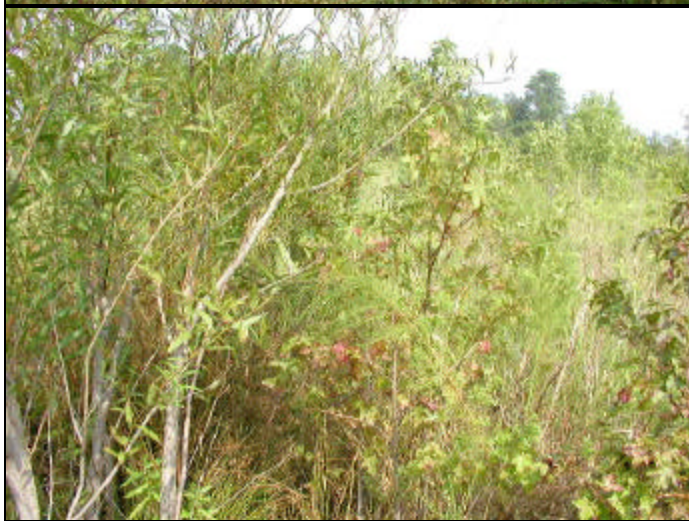
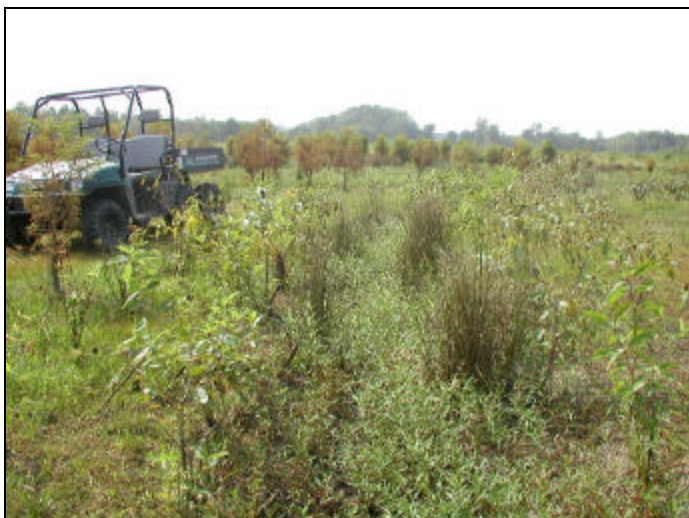
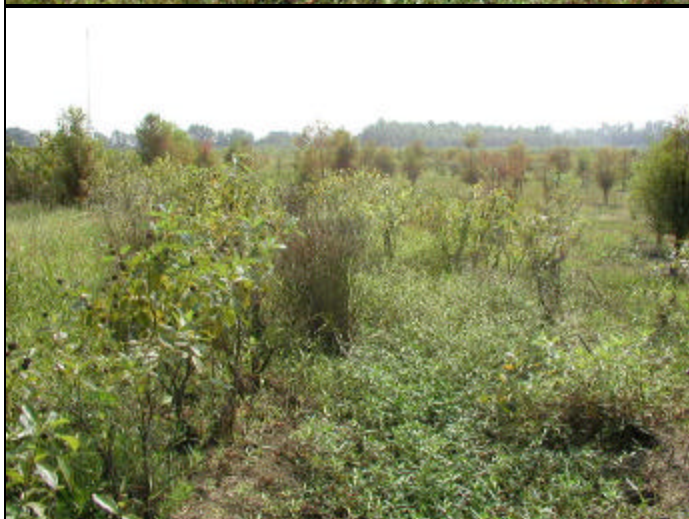
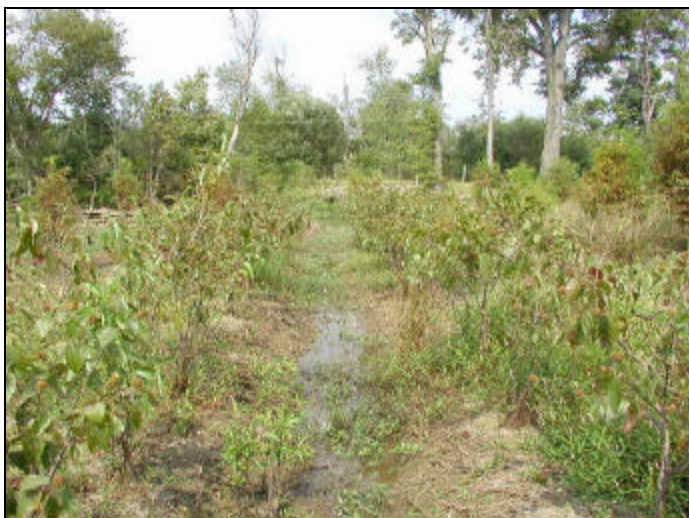
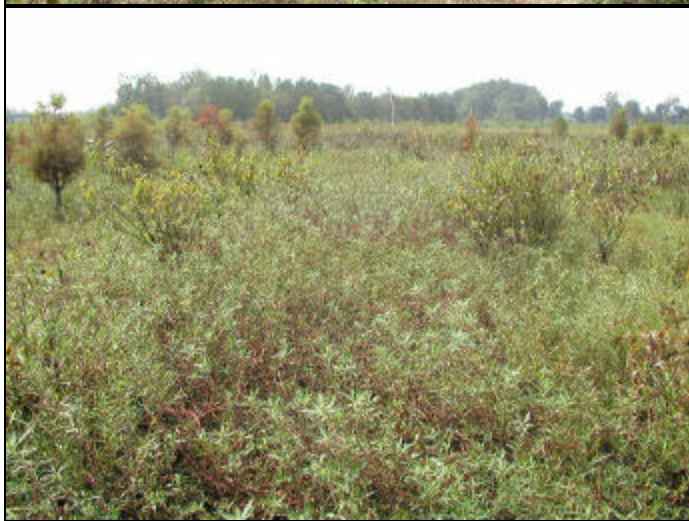
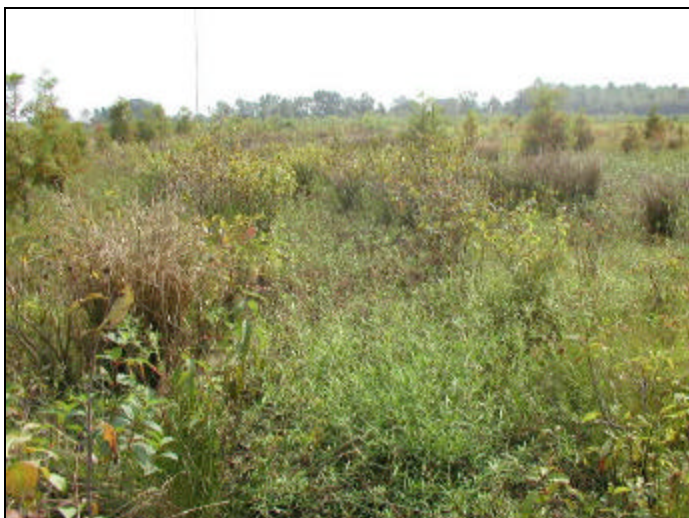
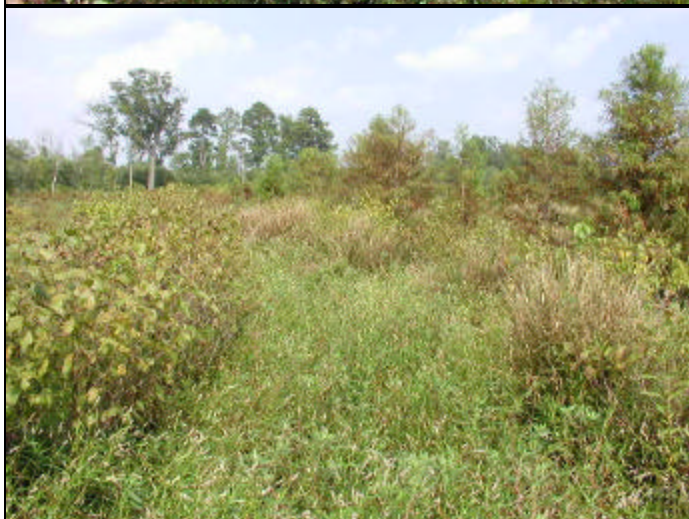
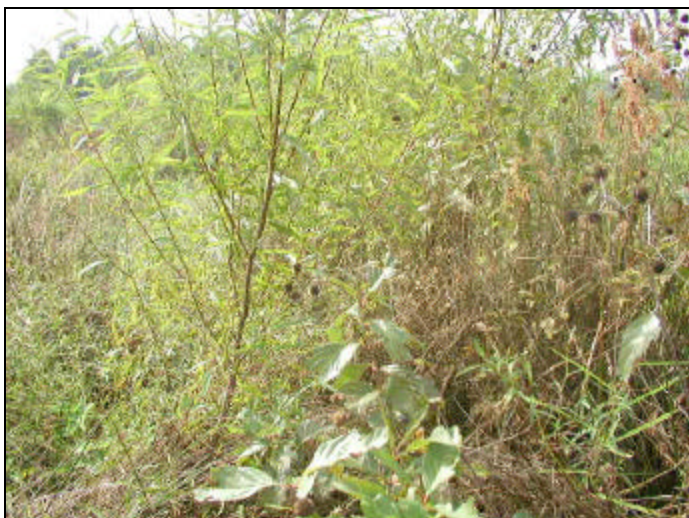
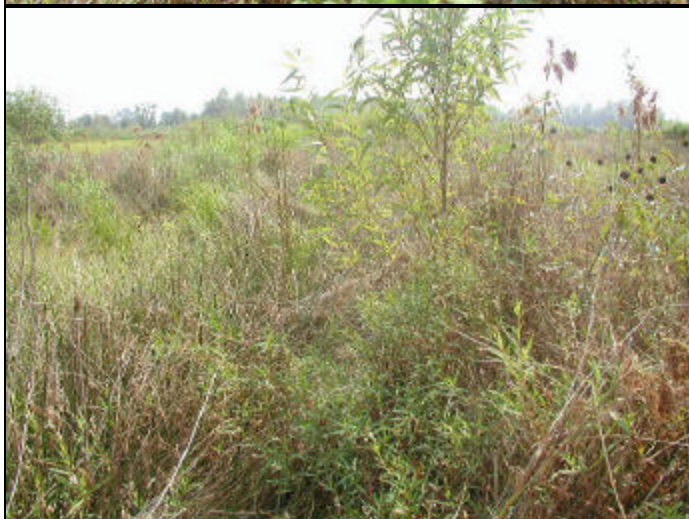
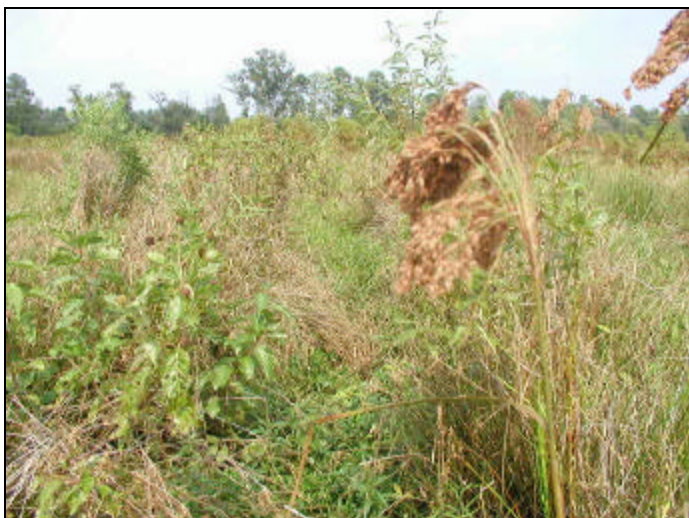
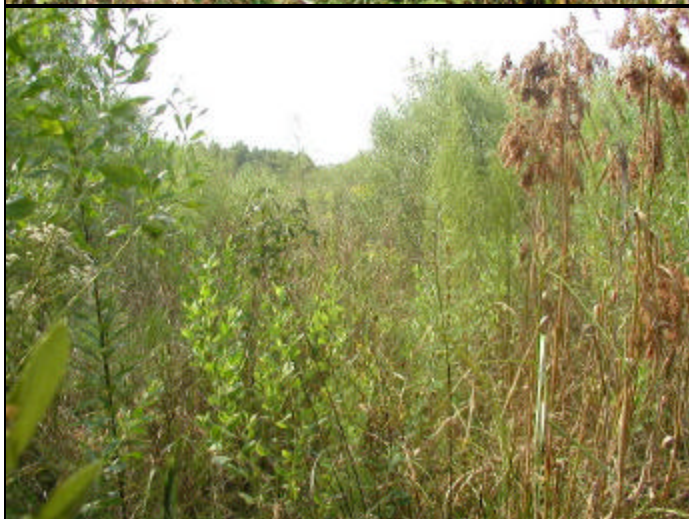
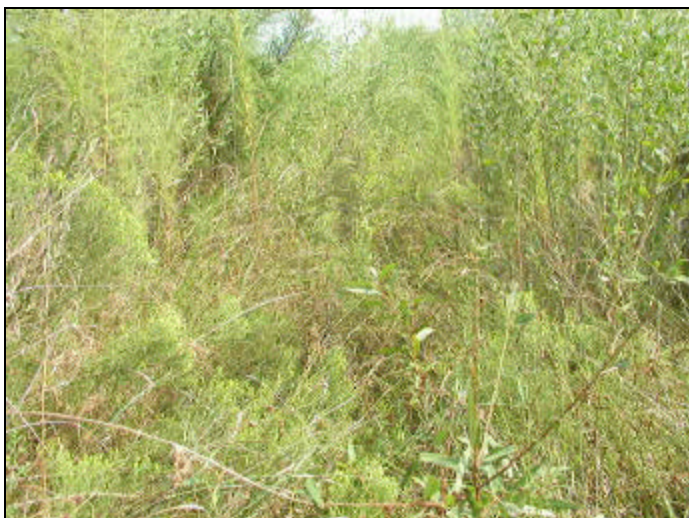
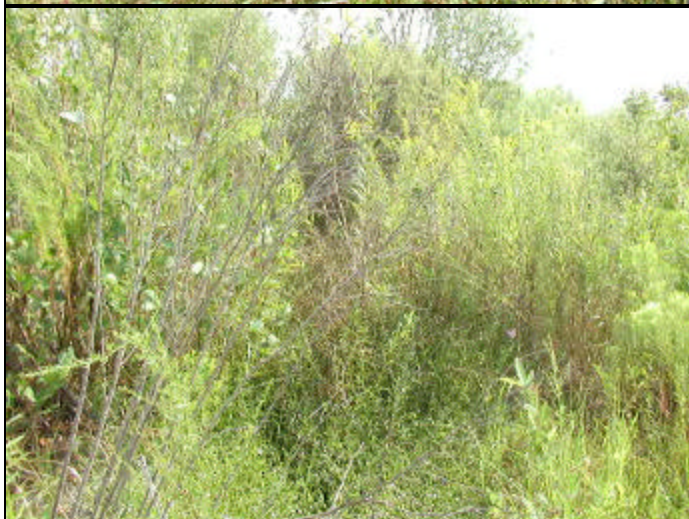
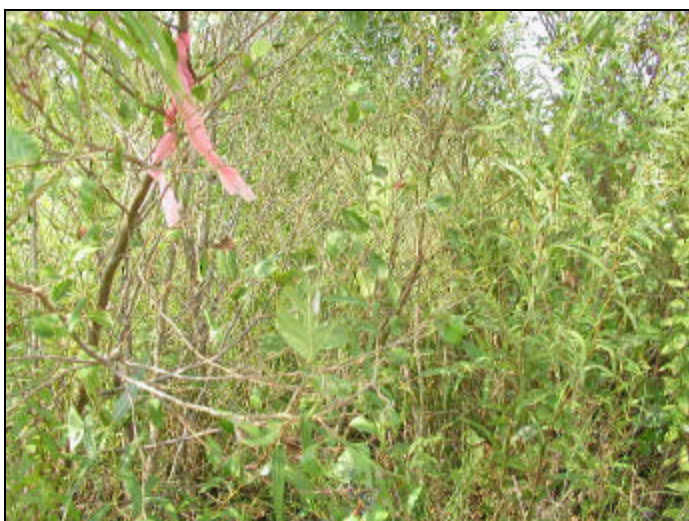
The stream channel was visually monitored on September 20, 2005. The monitoring indicated that the streambanks were stable with substantial woody and herbaceous vegetation throughout the entire length of the stream. Some of the species noted along the streambanks included black willow, buttonbush, silky dogwood, *Juncus* sp., woolgrass, *Baccharis* sp., and various grasses. Photos 9 through 25 show the conditions of the stream.
